# Manhole Inspection Summary

Manhole # S21KK\_006MH

Insp Date: **5/31/07 9:01 AM**

**Location** Address: **1837 CLIFTON AVE**

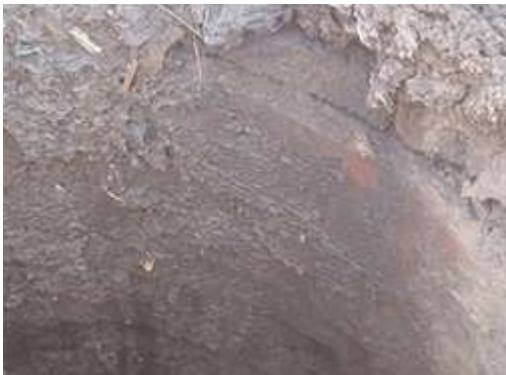
Defect 3

Infiltration: ☐ None ☐ Joint ☐ Cracks ☐ Mortar ☐ Roots ☒ Wall

INFILTRATION OF CORBEL WALL

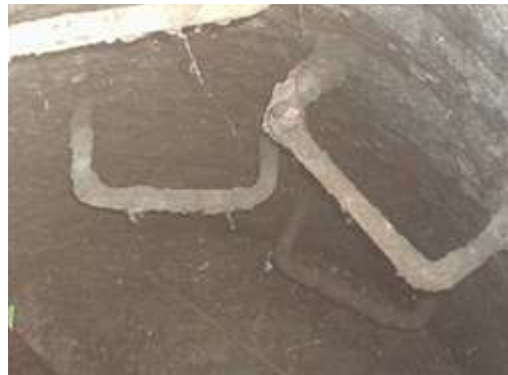
Defect 2

**Steps** Count: **4** Missing: **0** ☒ Corroded

CORRODED STEPS

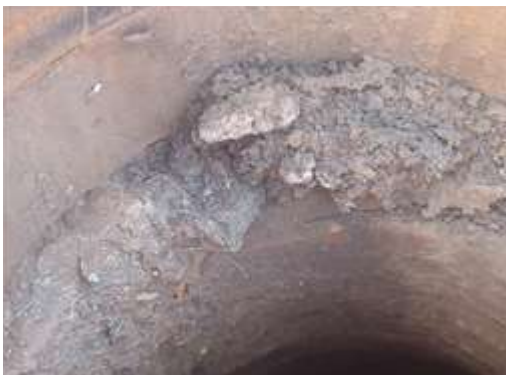
Defect 1

**Frame** Offset: **2** (in.) Condition: ☒ Sound ☐ Cracked ☐ Leaks

FRAME OFFSET

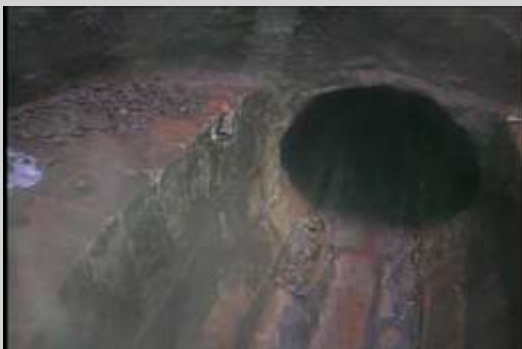
7 O'Clock Inflow

10 in. Circular Gravity Sewer  
Pipe In @ 7 O'Clock

Pipe Height: **9.6** (in.) Rod and Bar (Angled)  
Pipe Material: **Clay** ☐ Pipe Lined  
Invert Depth: **8.41** (ft.) Flow Characteristics: **Fast**  
Deposits: ☒ None ☐ Mud ☐ Sludge ☐ Debris ☐ Grease  
Silt Depth: (in.) Deposits Extent:  
Infiltration: **None** Pipe Seal Cond: **Cracked**
